Sandy Bridge Recall

Risk Assessment Post Mortem

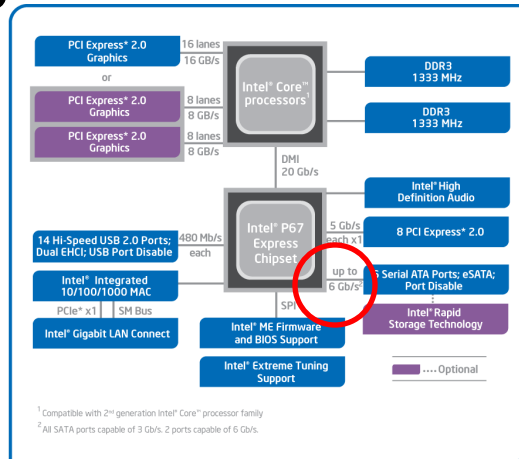
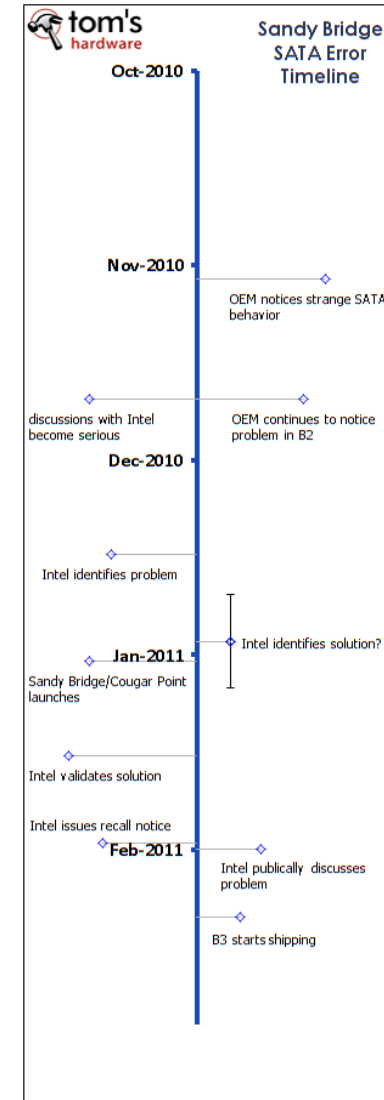
- OEMs notice degradation in 3 Gb/s SATA port of Cougar Point (Sandy Bridge chipset)
 - Failure rate 5-15%/3y
- Causes:
 - Physical: Low-voltage xistor connected to high-voltage supply
 - Management: Risk Assessment Hole
- Cost to Intel: \$1B
