Sandy Bridge Recall

Risk Assessment Post Mortem

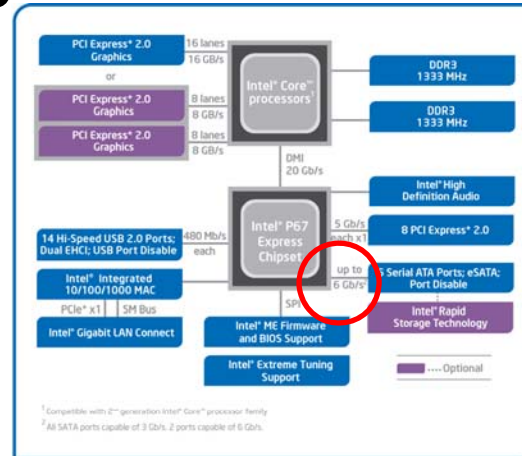
Intel P67 Express Chipset Platform Block Diagram

- OEMs notice degradation in 3 Gb/s SATA port of Cougar Point (Sandy Bridge chipset)
 - Failure rate 5-15%/3y
- Causes:
 - Physical: Low-voltage xistor connected to high-voltage supply
 - Management: Risk Assessment Hole
- Cost to Intel: \$1B

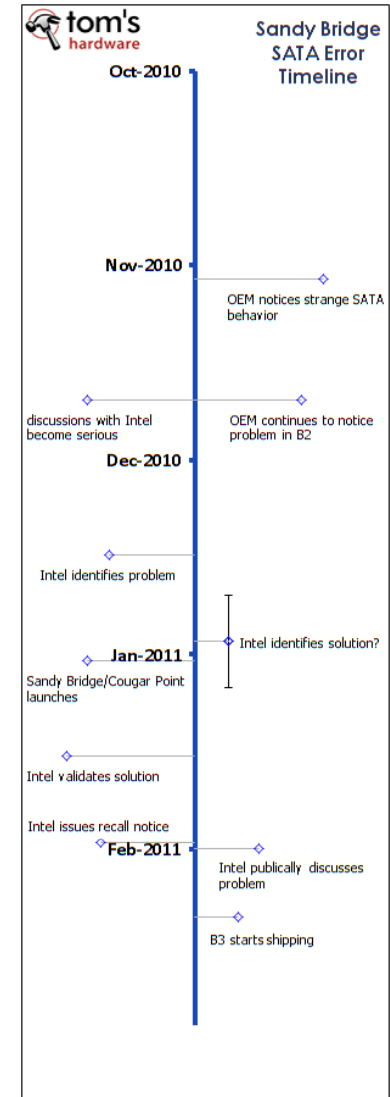
- Risk Assessment
 - Design Rule Check (SS required = 0)
 - Many exceptions manually invalidated.
 - How are they reviewed?
 - Si Validation (SS required = 1)
 - High-traffic I/O at accelerated stress not in validation suite.
 - How are Use Models determined, and reviewed?
- Learnings
 - This was caused by a failure in pre-Si Risk Assessment.
 - Use Model was incomplete.
 - Sample size had little to do with it.
